DEPARTMENT OF TRANSPORTATION

Quality Assurance and Source Inspection

Contract #: 04-0120F4Cty: SF/ALA Rte: 80 PM: 13.2/13.9File #: 69.28**WELDING INSPECTION REPORT****Resident Engineer:**Siegenthaler, Peter**Address:** 333 Burma Road**City:** Oakland, CA 94607**Report No:** WIR-021790**Date Inspected:** 14-Mar-2011**Project Name:** SAS Superstructure**OSM Arrival Time:** 700**Prime Contractor:** American Bridge/Fluor Enterprises, a JV**OSM Departure Time:** 1900**Contractor:** Zhenhua Port Machinery Company, Ltd (ZPMC), Changxing Island **Location:** Shanghai, China**CWI Name:** Li Yang and Zhu Zhong Hai**CWI Present:** Yes No**Inspected CWI report:** Yes No N/A**Rod Oven in Use:** Yes No N/A**Electrode to specification:** Yes No N/A**Weld Procedures Followed:** Yes No N/A**Qualified Welders:** Yes No N/A**Verified Joint Fit-up:** Yes No N/A**Approved Drawings:** Yes No N/A**Approved WPS:** Yes No N/A**Delayed / Cancelled:** Yes No N/A**Bridge No:** 34-0006**Component:** OBG Trial Assembly**Summary of Items Observed:**

Orthotropic Box Girder (OBG) at Trial Assembly Areas

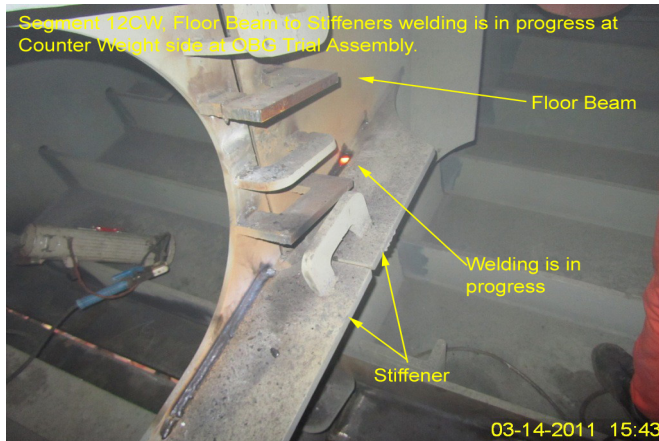
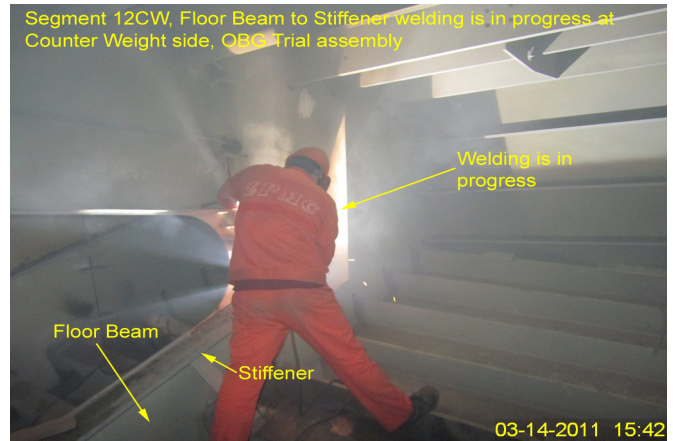
Please reference the pictures attached for more comprehensive details.
